O'Conner's Stream and Lake Management Plan

Final Report

Prepared for the Lower St. Croix Watershed Management Organization

Emmons and Olivier Resources, Inc.
651 Hale Avenue North
Oakdale, MN 55128

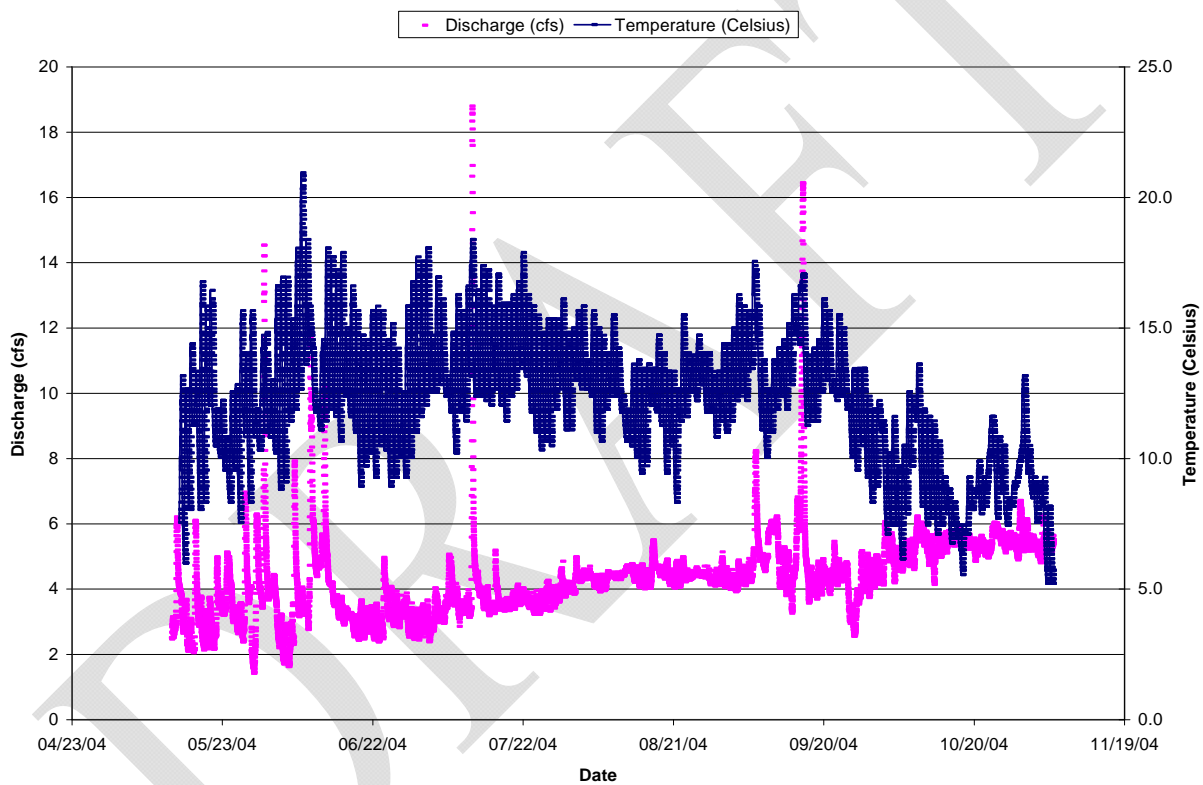
Figure 9: O’Conner’s Stream Temperature and Discharge, April-November 2004.

O’Conner’s Stream is continuously fed by the seepage of groundwater which in the region varies from 8° Celsius to 12°Celsius. Water temperature collected in the creek varies seasonally outside of the groundwater temperature range. The shift in stream temperature outside of the groundwater range is due to the seasonal ambient air temperature influence on stream temperature. Temperature data collected in 2004 by the WCD at County Road 21 illustrate the fluctuation of temperature through time (Figure 9). The maximum stream temperature recorded in 2004 was on June 7th and measured 20.9° Celsius (86°F). The minimum stream temperature recorded in 2004 was on November 4th and measured 5.2° Celsius (41°F).

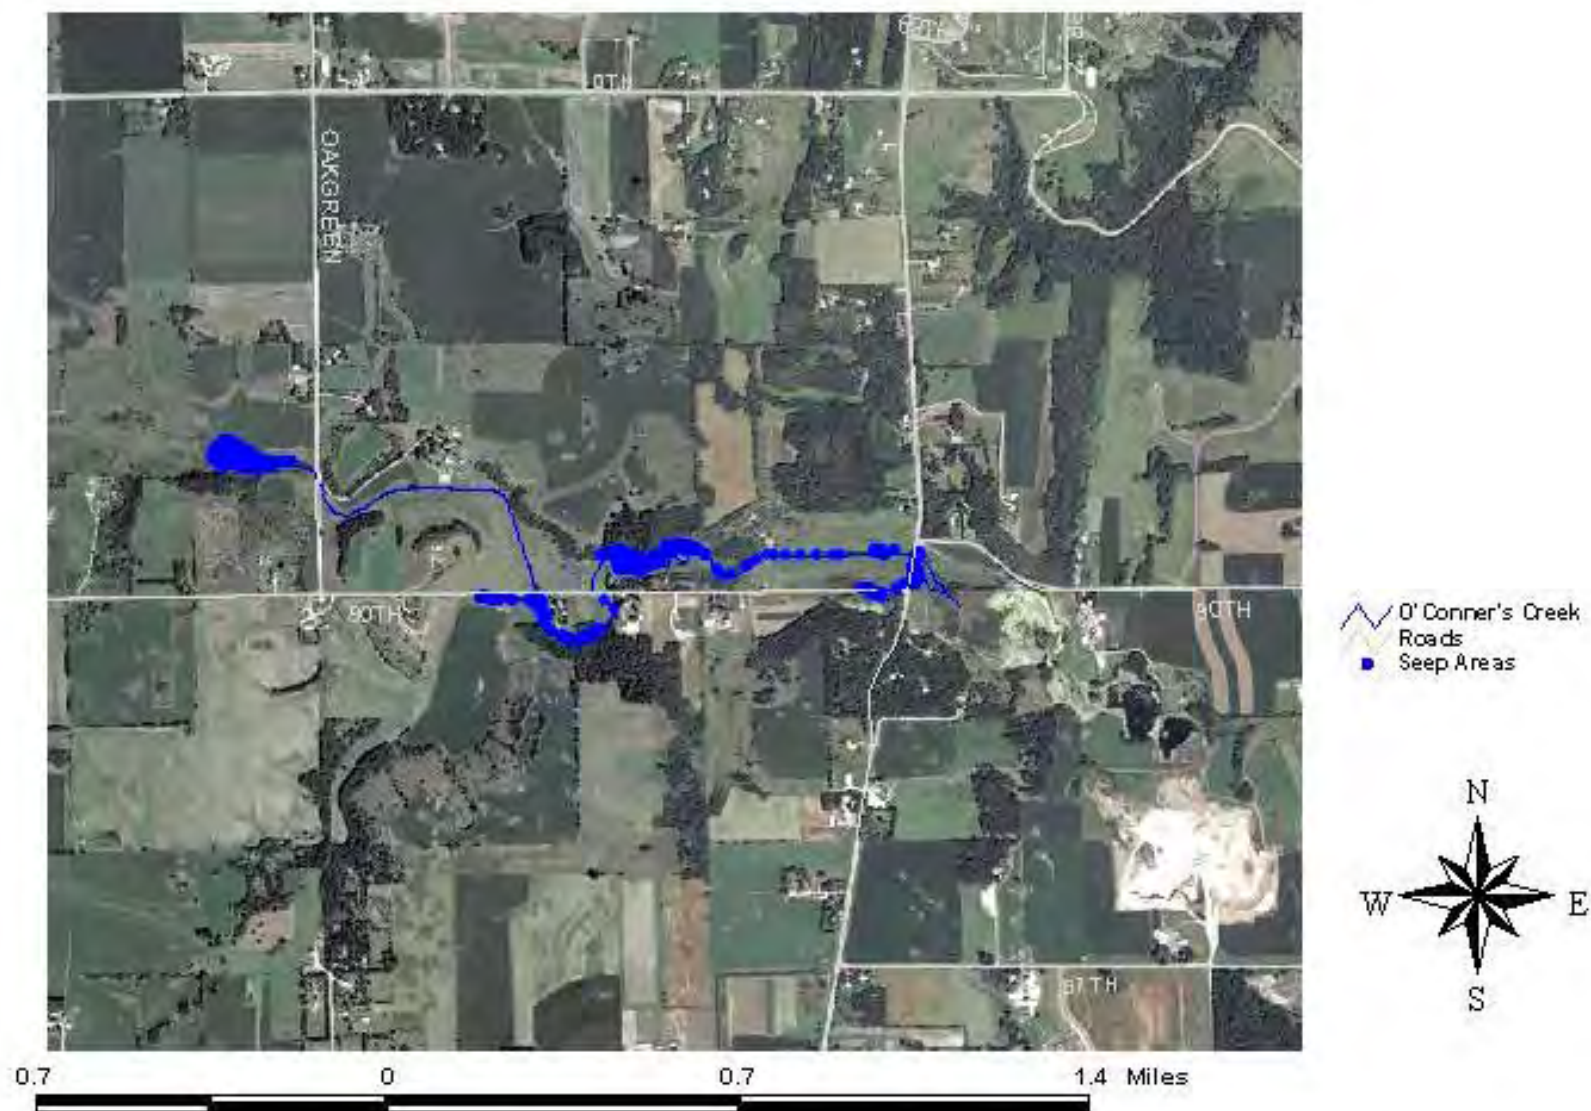
Figure 11: Groundwater Discharge Regions

An extensive spring inventory was conducted May 5, 2005 to identify recharge areas along O’Conner’s Stream. The majority of groundwater resurging along the stream is through slow seep recharge. Many of the seepage areas are identifiable by a reddish iron precipitate visible at the surface. Notable recharge areas along the stream include the wetland region west of Oakgreen Avenue South where the perennial stream begins, north of 80th Street South along the south side of the bluff, and east of County Road 21 (Figure 11). Two small springs were identified along the creek, one located south of the 80th Street South bridge and the other located on the west side of the bluff located north of 80th Street South. Figure 12 depicts a seep region located east of County Road 21. Note the orange iron precipitate visible at surface.

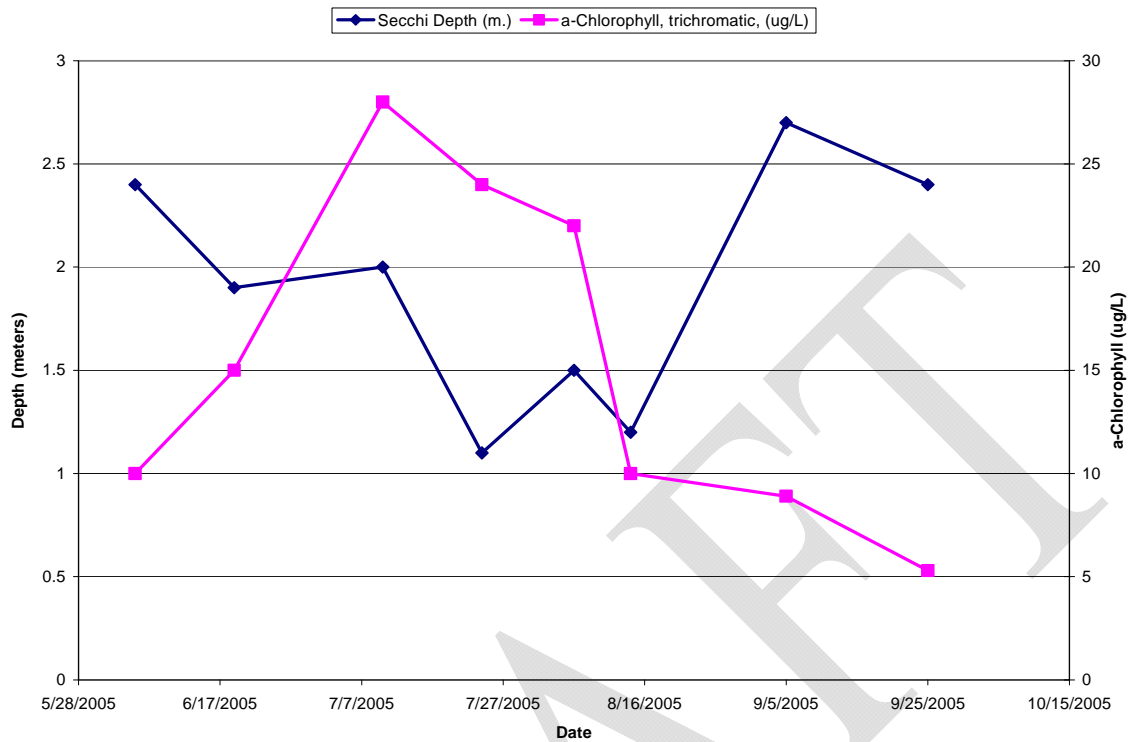
Figure 15: CAMP Data 2005, Secchi Depth and a Chlorophyll

Figures 15 and 16 depict the values for parameters collected at O'Conner's Lake for the CAMP program in 2005. It is important to note that the values reported above are from one year of monitoring data. To accurately characterize the quality of a lake the assessment should be based on several years of monitoring data.
