# Concept Design Report

## Trout Brook Watershed Improvements Afton Alps, Afton, Minnesota

South Washington Watershed District

August 9, 2012

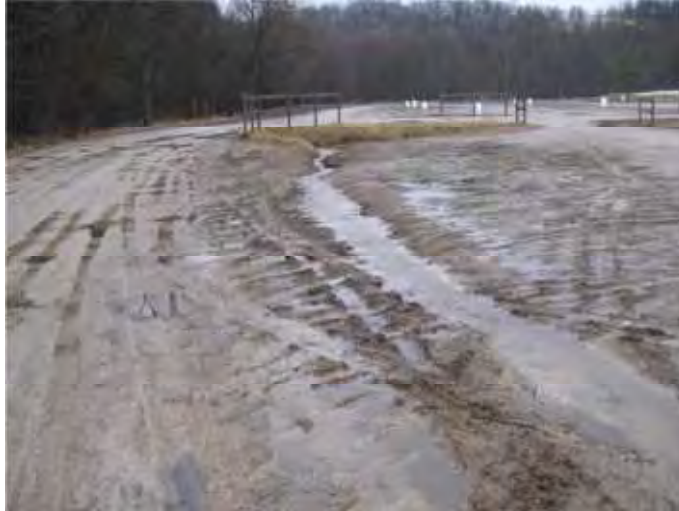
**Figure 1. Lower Parking Lot and Road During Runoff Event (Photo: HR Green)**

Within the Afton Alps property, the primary source of sediment loading to Trout Brook is runoff from the parking lots and roads. During heavy rain events and the spring melt, rapid runoff from the steep upland slopes flows over the gravel and mud surfaces and into the stream adjacent to the main road. Table 1 below indicates that the suspended solids concentration in Trout Brook at a sampling point just downstream from the Afton Alps property is highly correlated to discharge and storm events. Figure 1 below shows the condition of the existing parking lot and road during an early spring runoff event – there is a culvert inlet in the center of the photo at the base of the mud drainage swale, the culvert leads directly to Trout Brook.

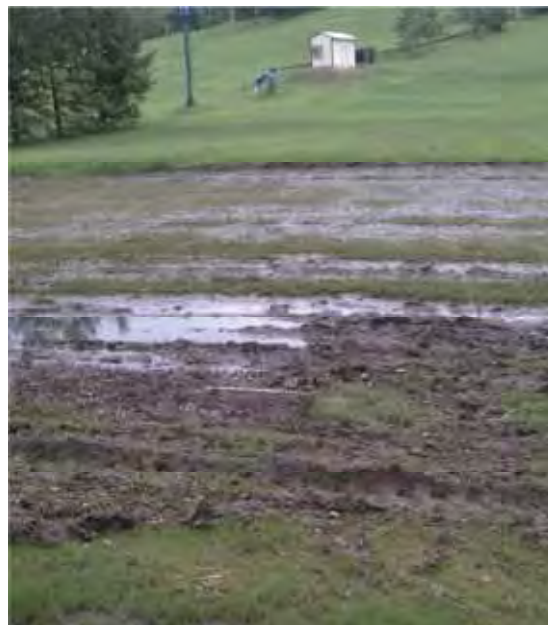
**Figure 3. Typically Muddy Conditions at Base of Slope Due to High Water Table (Photo: HR Green)**

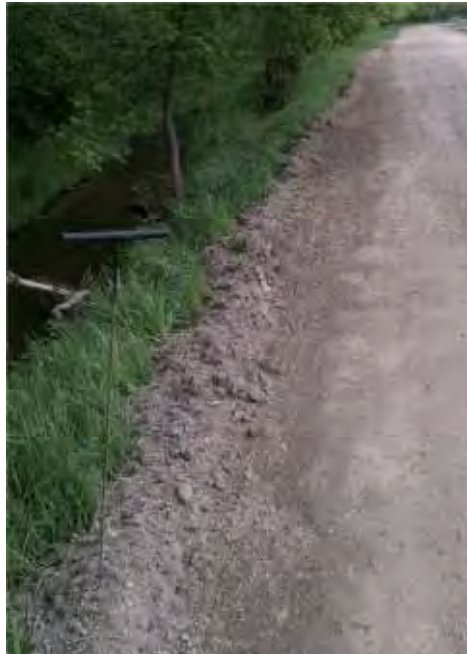
**Figure 4. Grading spoil on creek bank (Photo: HR Green)**

Due to the proximity of roads and parking lots to the creek, and the lack of an effective riparian barrier in many locations, special maintenance requirements exist on this property. Re-grading of roads and parking lots should be minimized as much as possible. When re-grading is absolutely necessary, care should be taken to avoid deposition of grading spoil near the creek banks or near surface drainage swales leading to the creek (see Figure 4). Spoil should be stockpiled in a location that is unlikely to create sediment laden runoff near the creek (see Figure 5). Any stockpiles remaining onsite and containing finely textured soil material should be located away from drainage paths, and encircled with silt-fencing or other appropriate measures to control sediment laden runoff.

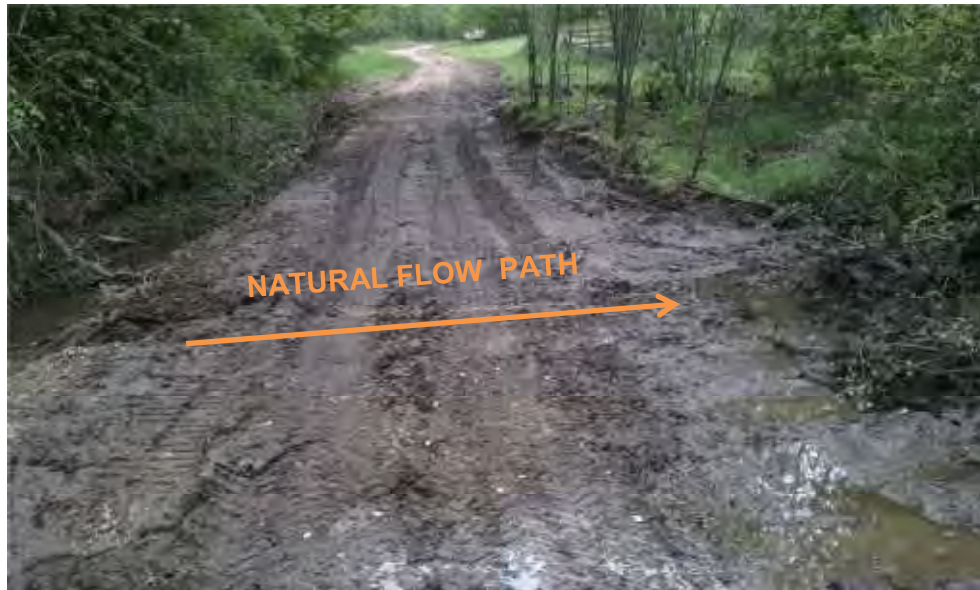
**Figure 6. Access road is routinely re-graded which stirs up sediment due to dirt / gravel surface; damage is due to seasonal cross drainage (Photo: HR Green)**

Runoff from the Afton Alps ski slopes crosses the access road in one concentrated location just north of the base of ski lift number 11 (see Figure 6). Additional runoff is distributed along the remaining ~500 feet of road between lift #11 and the Meadows parking lot. This section of road should be excavated and replaced with larger open-pore gravel (no fines). A culvert should be installed at the concentrated runoff location near lift #11. A small roadside swale should be installed along the west side of the road to deliver distributed runoff to the sand filter at the east end of the Meadows Chalet parking lot (see map and item #3 below). This design would improve runoff water quality and reduce the maintenance burden on the property owners.

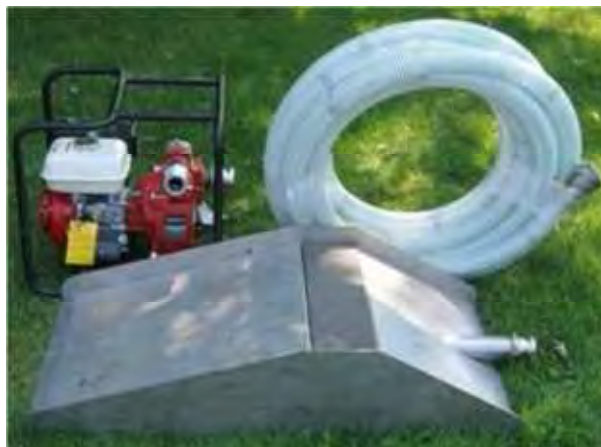
Figure 8. In-stream Bed Load Collection Device (photo courtesy of Streamside Systems Inc.)

An additional option is the use of a ramp-and-hopper type in-stream bed load collection device, see figure 8 below. This device is available with a 1 yd<sup>3</sup> hopper underneath which would be pumped out as needed. The pumped slurry would be routed to a remote de-watering bin which allows decanted water to drain back to the stream. The bin is compatible with conventional roll-off boxes for convenient offsite disposal. Table 3 provides a comparison matrix for the three options.

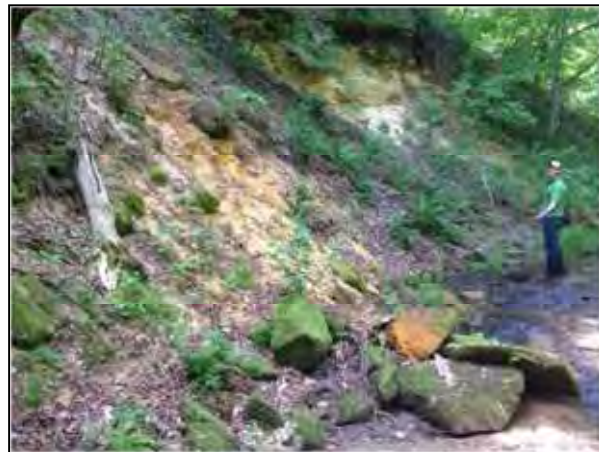
Figure 10. Exposed bedrock in higher gradient slope upstream of the Afton Alps Ski Area (Photo: Inter-Fluve).

The Trout Brook watershed is underlain primarily by Paleozoic bedrock dominated by dolomitic sandstone and limestone. Trout Brook flows through Upper Cambrian sandstone from its headwaters to its mouth in the St. Croix River (Figure 9). A small section of the lower portion of Trout Brook and its watershed are within the Lower Ordovician dolomitic limestone. Through much of the watershed, the bedrock is currently obscured below the ground surface. Some of the sandstone bedrock is exposed on hillsides, however, as Trout Brook flows through the steeper topography in the middle of the watershed (Figure 10).

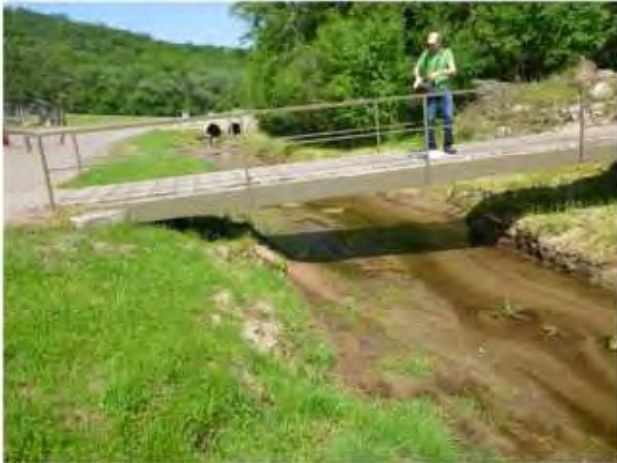
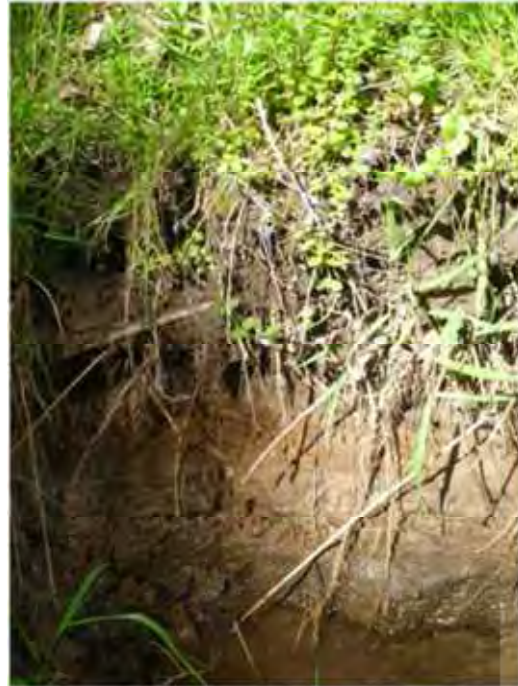
Figure 12. Sandy floodplain alluvium along Trout Brook in the study area (photos: Inter-Fluve).

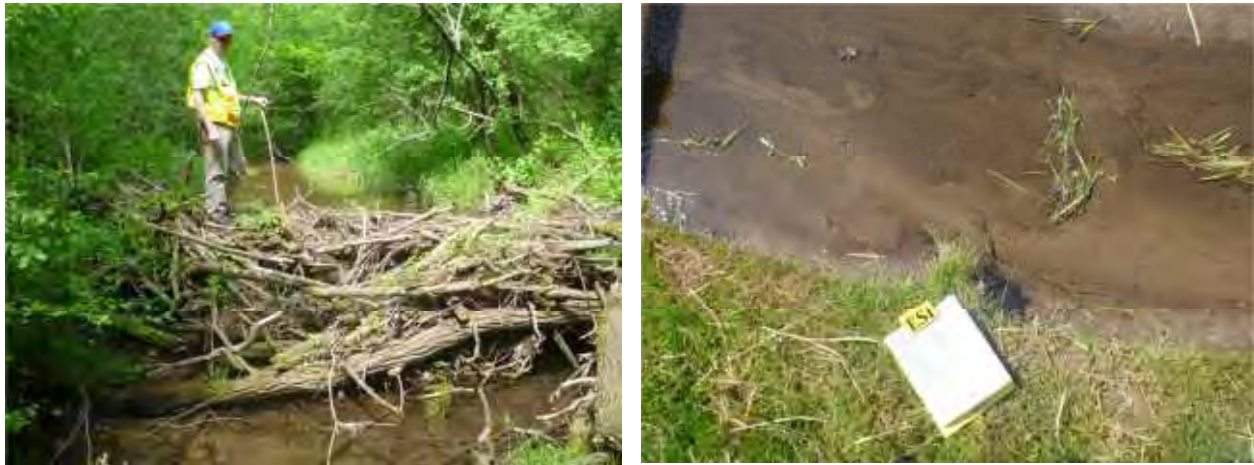
**Figure 18. Sand accumulates behind obstructions (left) as well as in the pools and runs through most of the length of the stream (right). (Photos: Inter-Fluve)**

Channel bed, bank, and floodplain sediments were investigated to understand the sediment transport history of the site as well as the existing grain size distribution of the stream. Upstream of the Afton Alps Ski Area, sand continues to be transported from upstream sources, accumulating in pools and behind obstructions such as log jams or beaver dams (Figure 18). Small to large gravel were identified along riffles, while sand dominated the majority of the stream, which consisted of runs and shallow pools. The stream banks were primarily composed of sand and sandy loam as were the floodplain and terrace surfaces. Pits dug into the floodplain surface, which was the channel bed in the mid-1900s, revealed multiple feet of sand with occasional organic layers. Within the Afton Alps property, the channel bed grain size ranged from fine sand to gravel and cobble (Figure 19). Upstream of the eastern-most culvert near the ski lodge, the channel slope is relatively low-gradient and sand from upstream sources accumulates within the channel. Downstream in the straightened ditch, the channel maintains a steeper riffle-pool form. Sand from upstream sources as well as from runoff from parking lots and roads has generally filled in many of the pools that may exist otherwise. Small riffles and shallow pools were observed, but the stream was dominated by long, sandy runs.

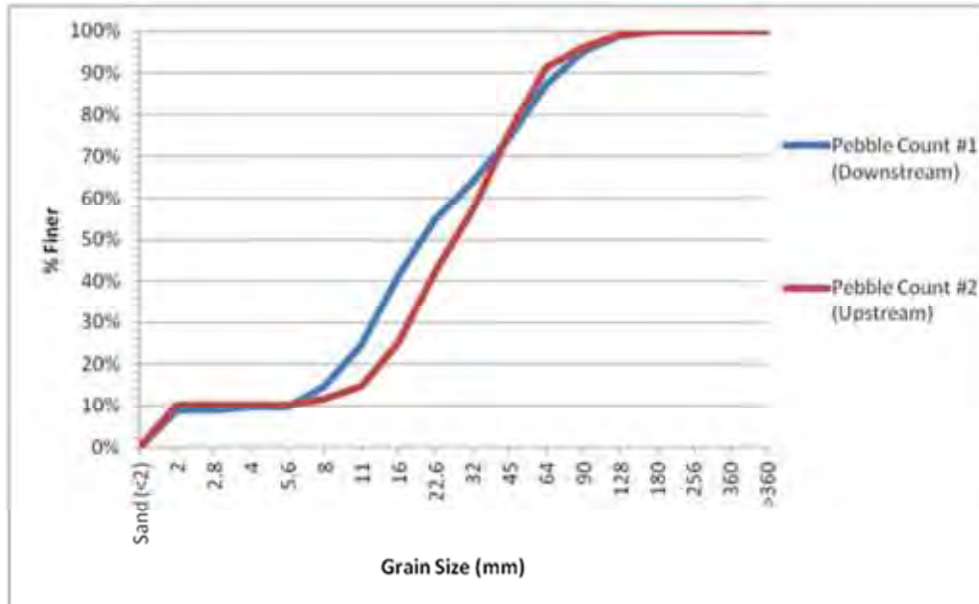
**Figure 19. Grain size distribution of channel bed upstream of the western-most road crossing near the Alps Chalet (#2) and downstream of the eastern-most road crossing near the Alps Chalet (#1).**

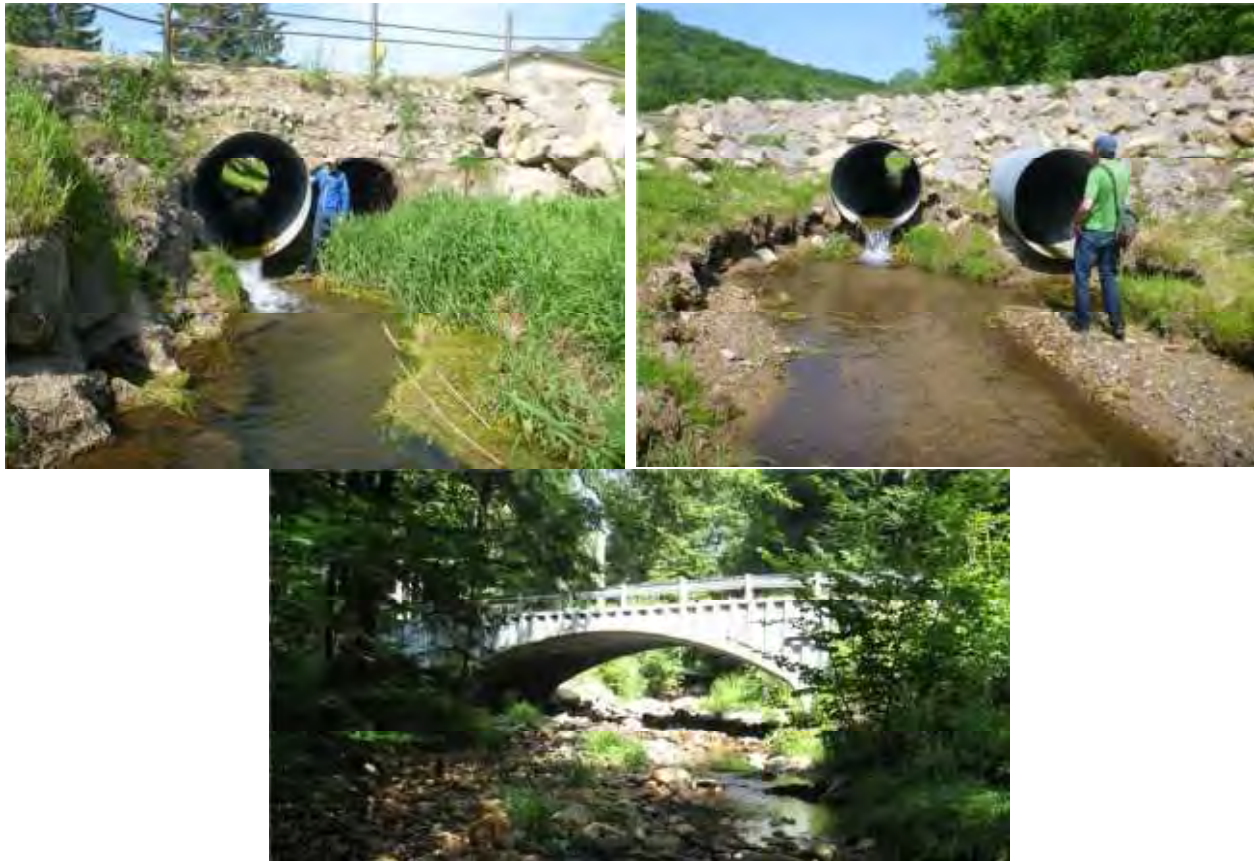
**Figure 21. The culverts under both road crossings near the Afton Alps lodge are all perched and undersized, leading to erosion and ecological concerns (top photos). These can be replaced by bottomless arch culverts (left) or bridge spans for better stream flow. (Photos: Inter-Fluve)**

*Culvert replacement* - The culverts beneath the two road crossings near the ski lodge are undersized, which results in stream destabilization, degradation of aquatic habitat, and creation of a fish-passage barrier. We recommend replacing these culverts with bridge spans or bottomless arch culverts (Figure 21; see also Exhibit B2 in Appendix B). This would allow the flood flows to pass through without resulting in excessive erosion and would improve habitat and fish passage.

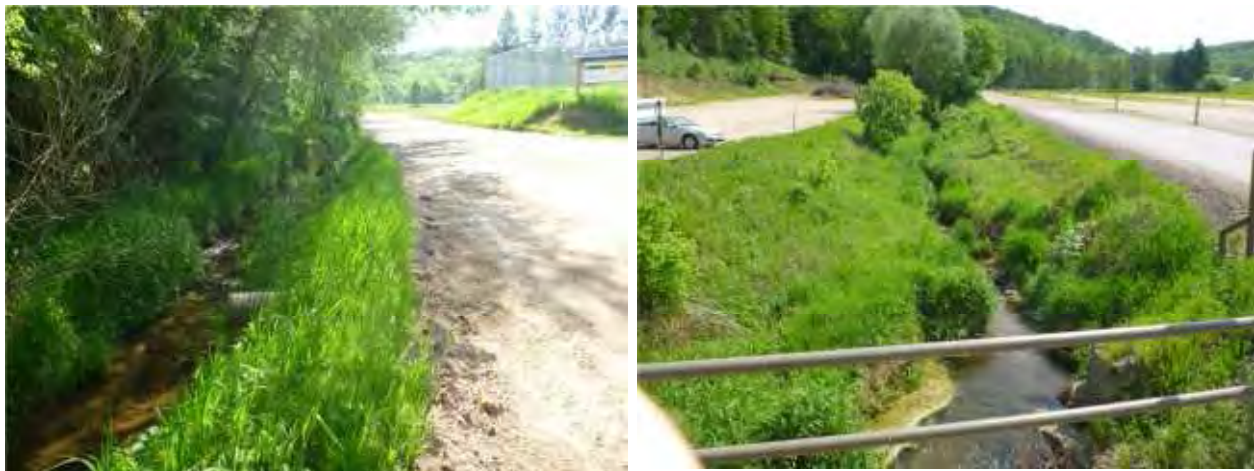
**Figure 22. Very little vegetative buffer exists between roads and parking lots and the stream channel. (Photos: Inter-Fluve)**

*Buffers and re-vegetation* - Through most of the stream length within the Afton Alps property, the buffer between roads, parking areas, and the stream is less than 5 ft (Figure 22). The lack of a sufficiently wide buffer results in excessive stormwater runoff, decreased bank stabilization, and decreased water quality due to lack of canopy cover, shade, and in-stream cover. We recommend increasing the buffer width to at least 15 ft and planting appropriate forbs, trees, and shrubs. Vegetation that meets the aesthetic goals of the ski area can be planted where appropriate.

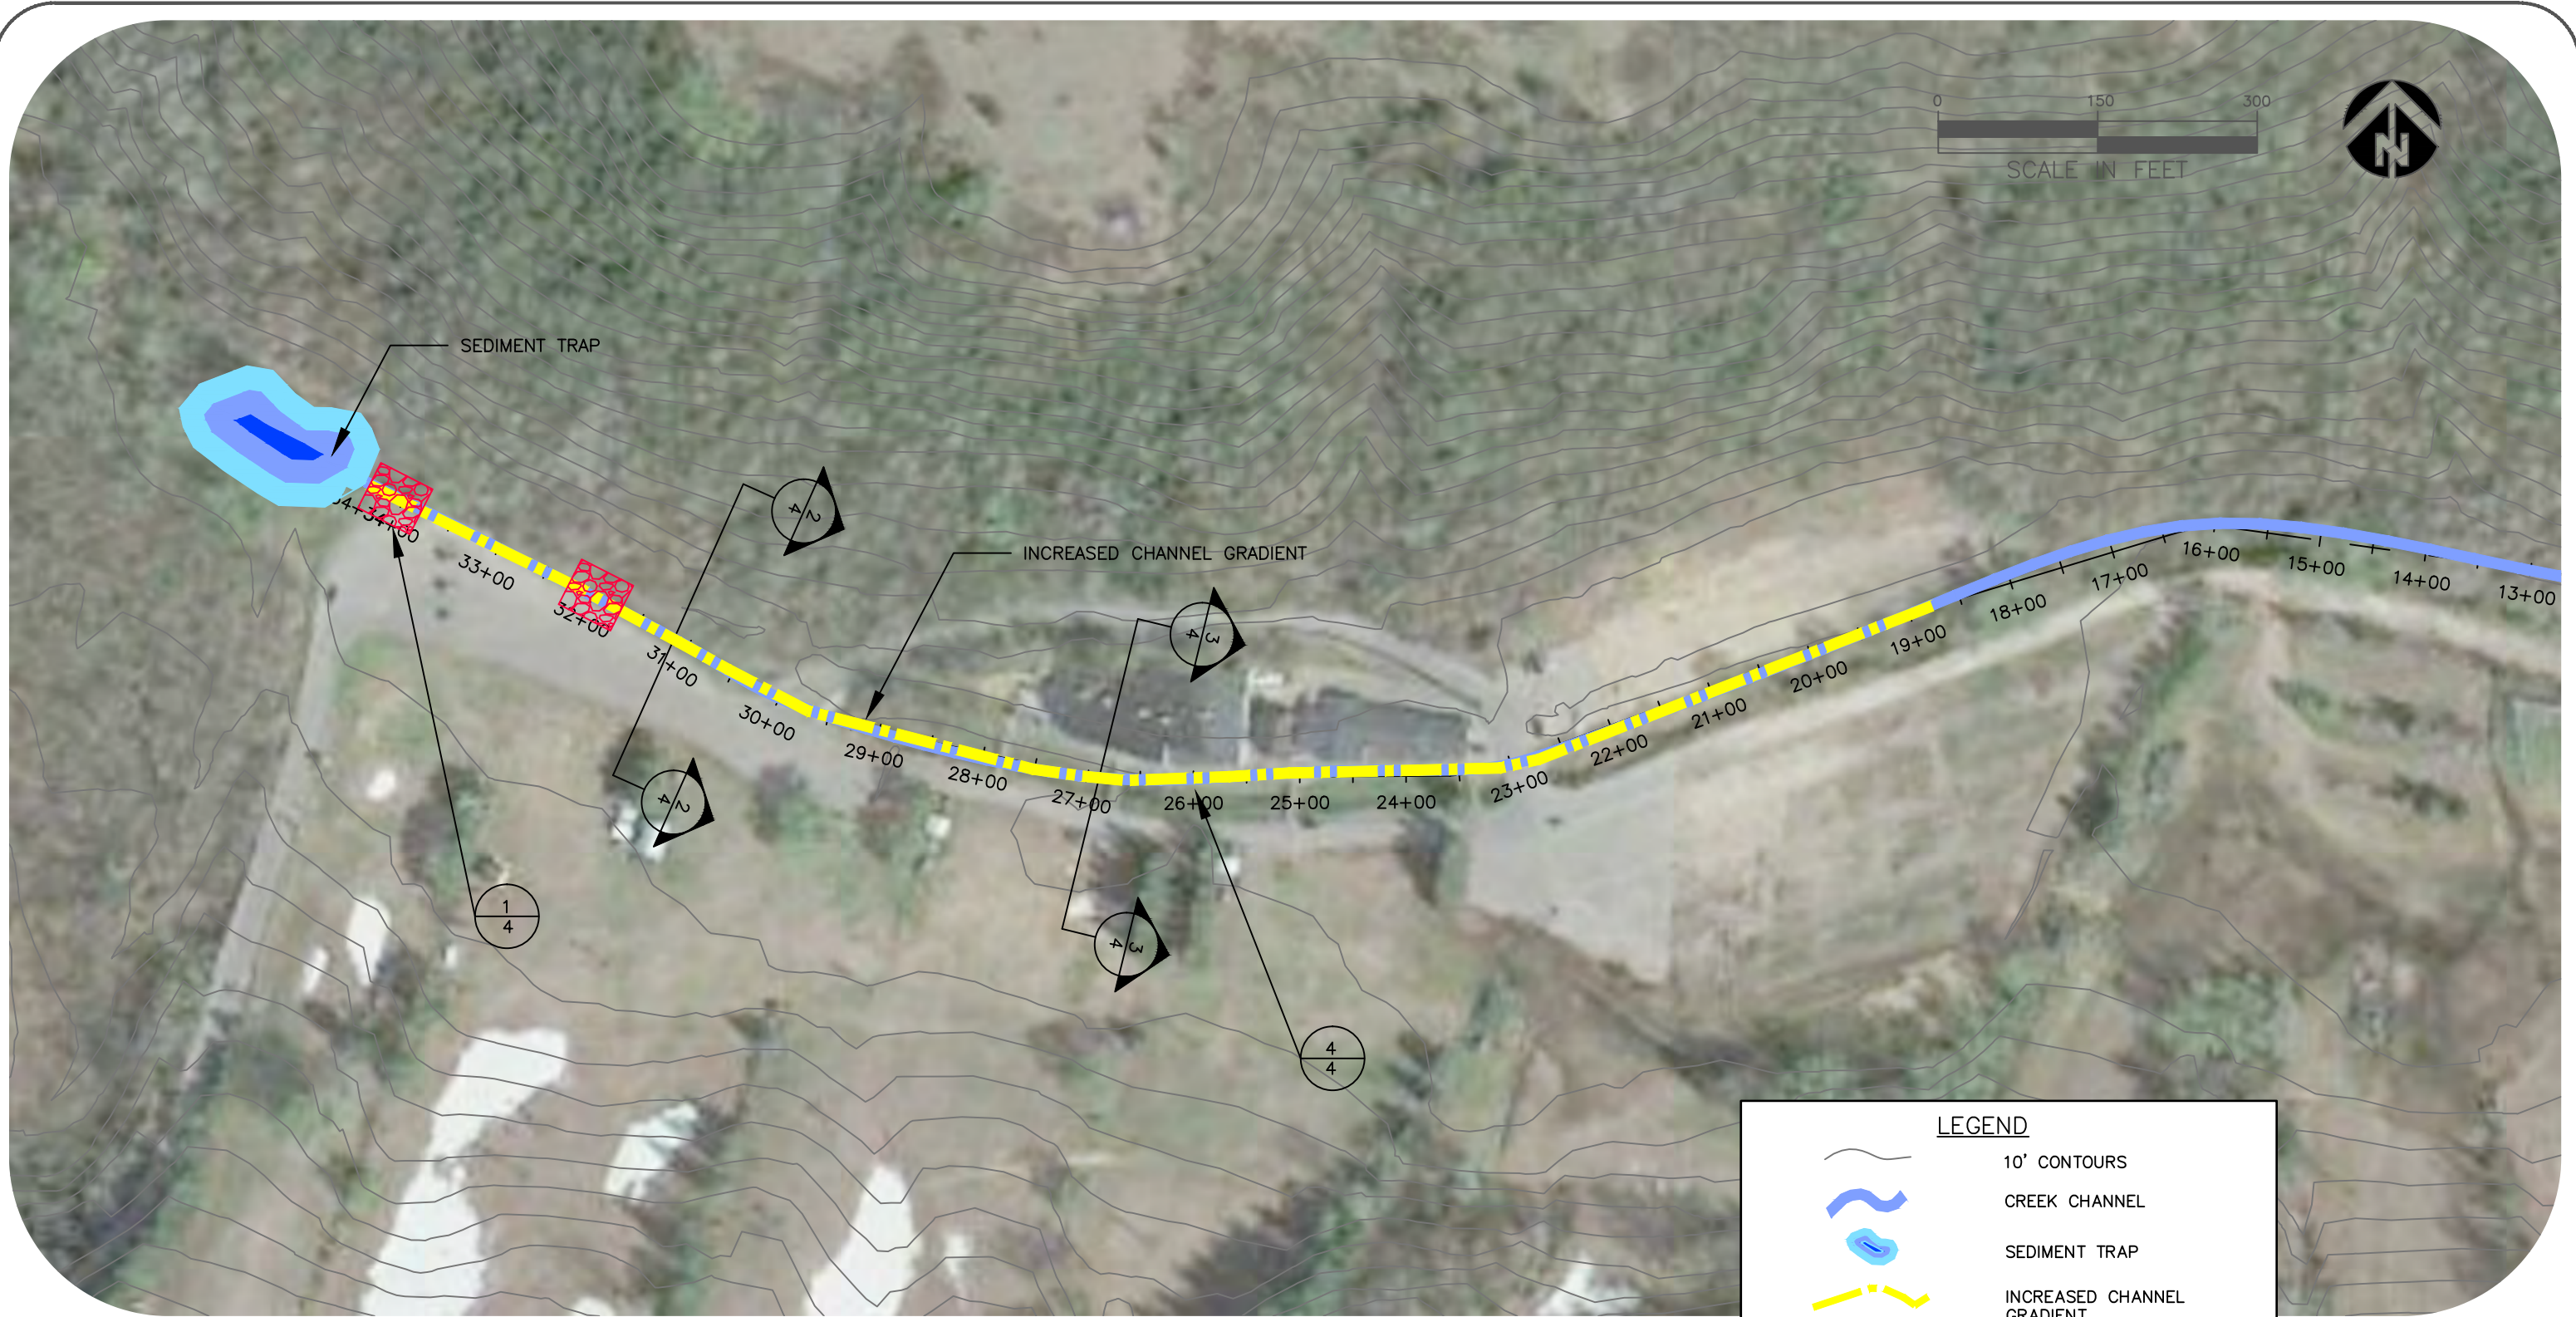
PLAN VIEW PROPOSED CONDITIONS

SEDIMENT TRAP

INCREASED CHANNEL GRADIENT

*Sediment trap* - Because the volume of sediment continuing to enter the Afton Alps property from unknown upstream sources is not likely to stop in the near future, we recommend constructing a series of steep riffles and deep scour pools upstream of the western-most road crossing. These deep scour pools would capture the sediment that is transported from upstream. Because of the proximity to the entrance to the ski area and parking lot, the sediment

*Channel re-construction* - Another method of transporting sediment is to steepen the channel and increase the flow velocities so sand is unable to be deposited as frequently. This can be accomplished by designing and constructing a narrow low-flow channel consisting of cobble/boulder riffles and steps with small pools in between. These riffles will also provide adequate grade control, which will become necessary when the culverts are replaced. This low flow channel would be built within a higher flow channel that would likely contain the approximate 5-yr flood. Channel banks would be stabilized using a variety of bioengineering techniques. The channel bed would be constructed so as to be passable by native fish and would provide a variety of habitat features throughout. Channel re-construction would likely need to occur from the upstream extent of the property to downstream of the eastern-most road crossing (approximately 1500 ft).
