# ENVIRONMENTAL ASSESSMENT WORKSHEET

1. **Project title:** Central Draw Storage Facility (CDSF) Overflow Project: Phase II – Phase V

# Cottage Grove Ravine Regional Park Erosion Analysis

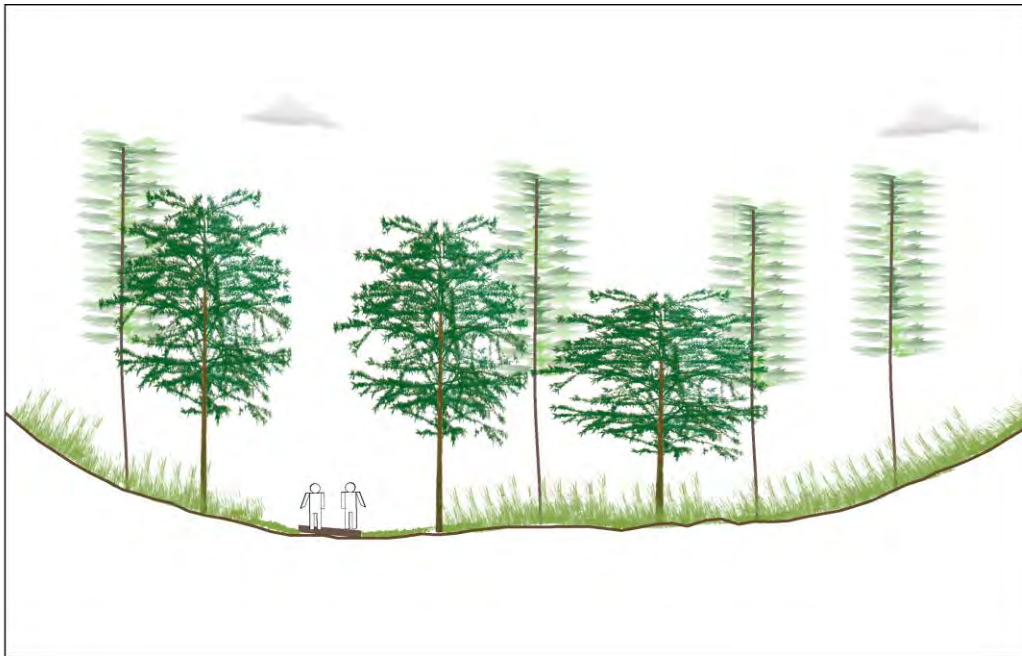
**Figure 1: Rendering Showing the Use of Vegetation Management**

Managing the vegetation within the ravine is an option to provide stability to the channel in cases where more invasive techniques are not warranted. Restoring the ravine to native habitat would allow longer native grasses to grow and provide the necessary erosion protection. This stabilization alternative would require removal of the buckthorn, other thick underbrush, removal of deadfall, and removal of live trees to open the canopy. The area would then be seeded with native grasses.

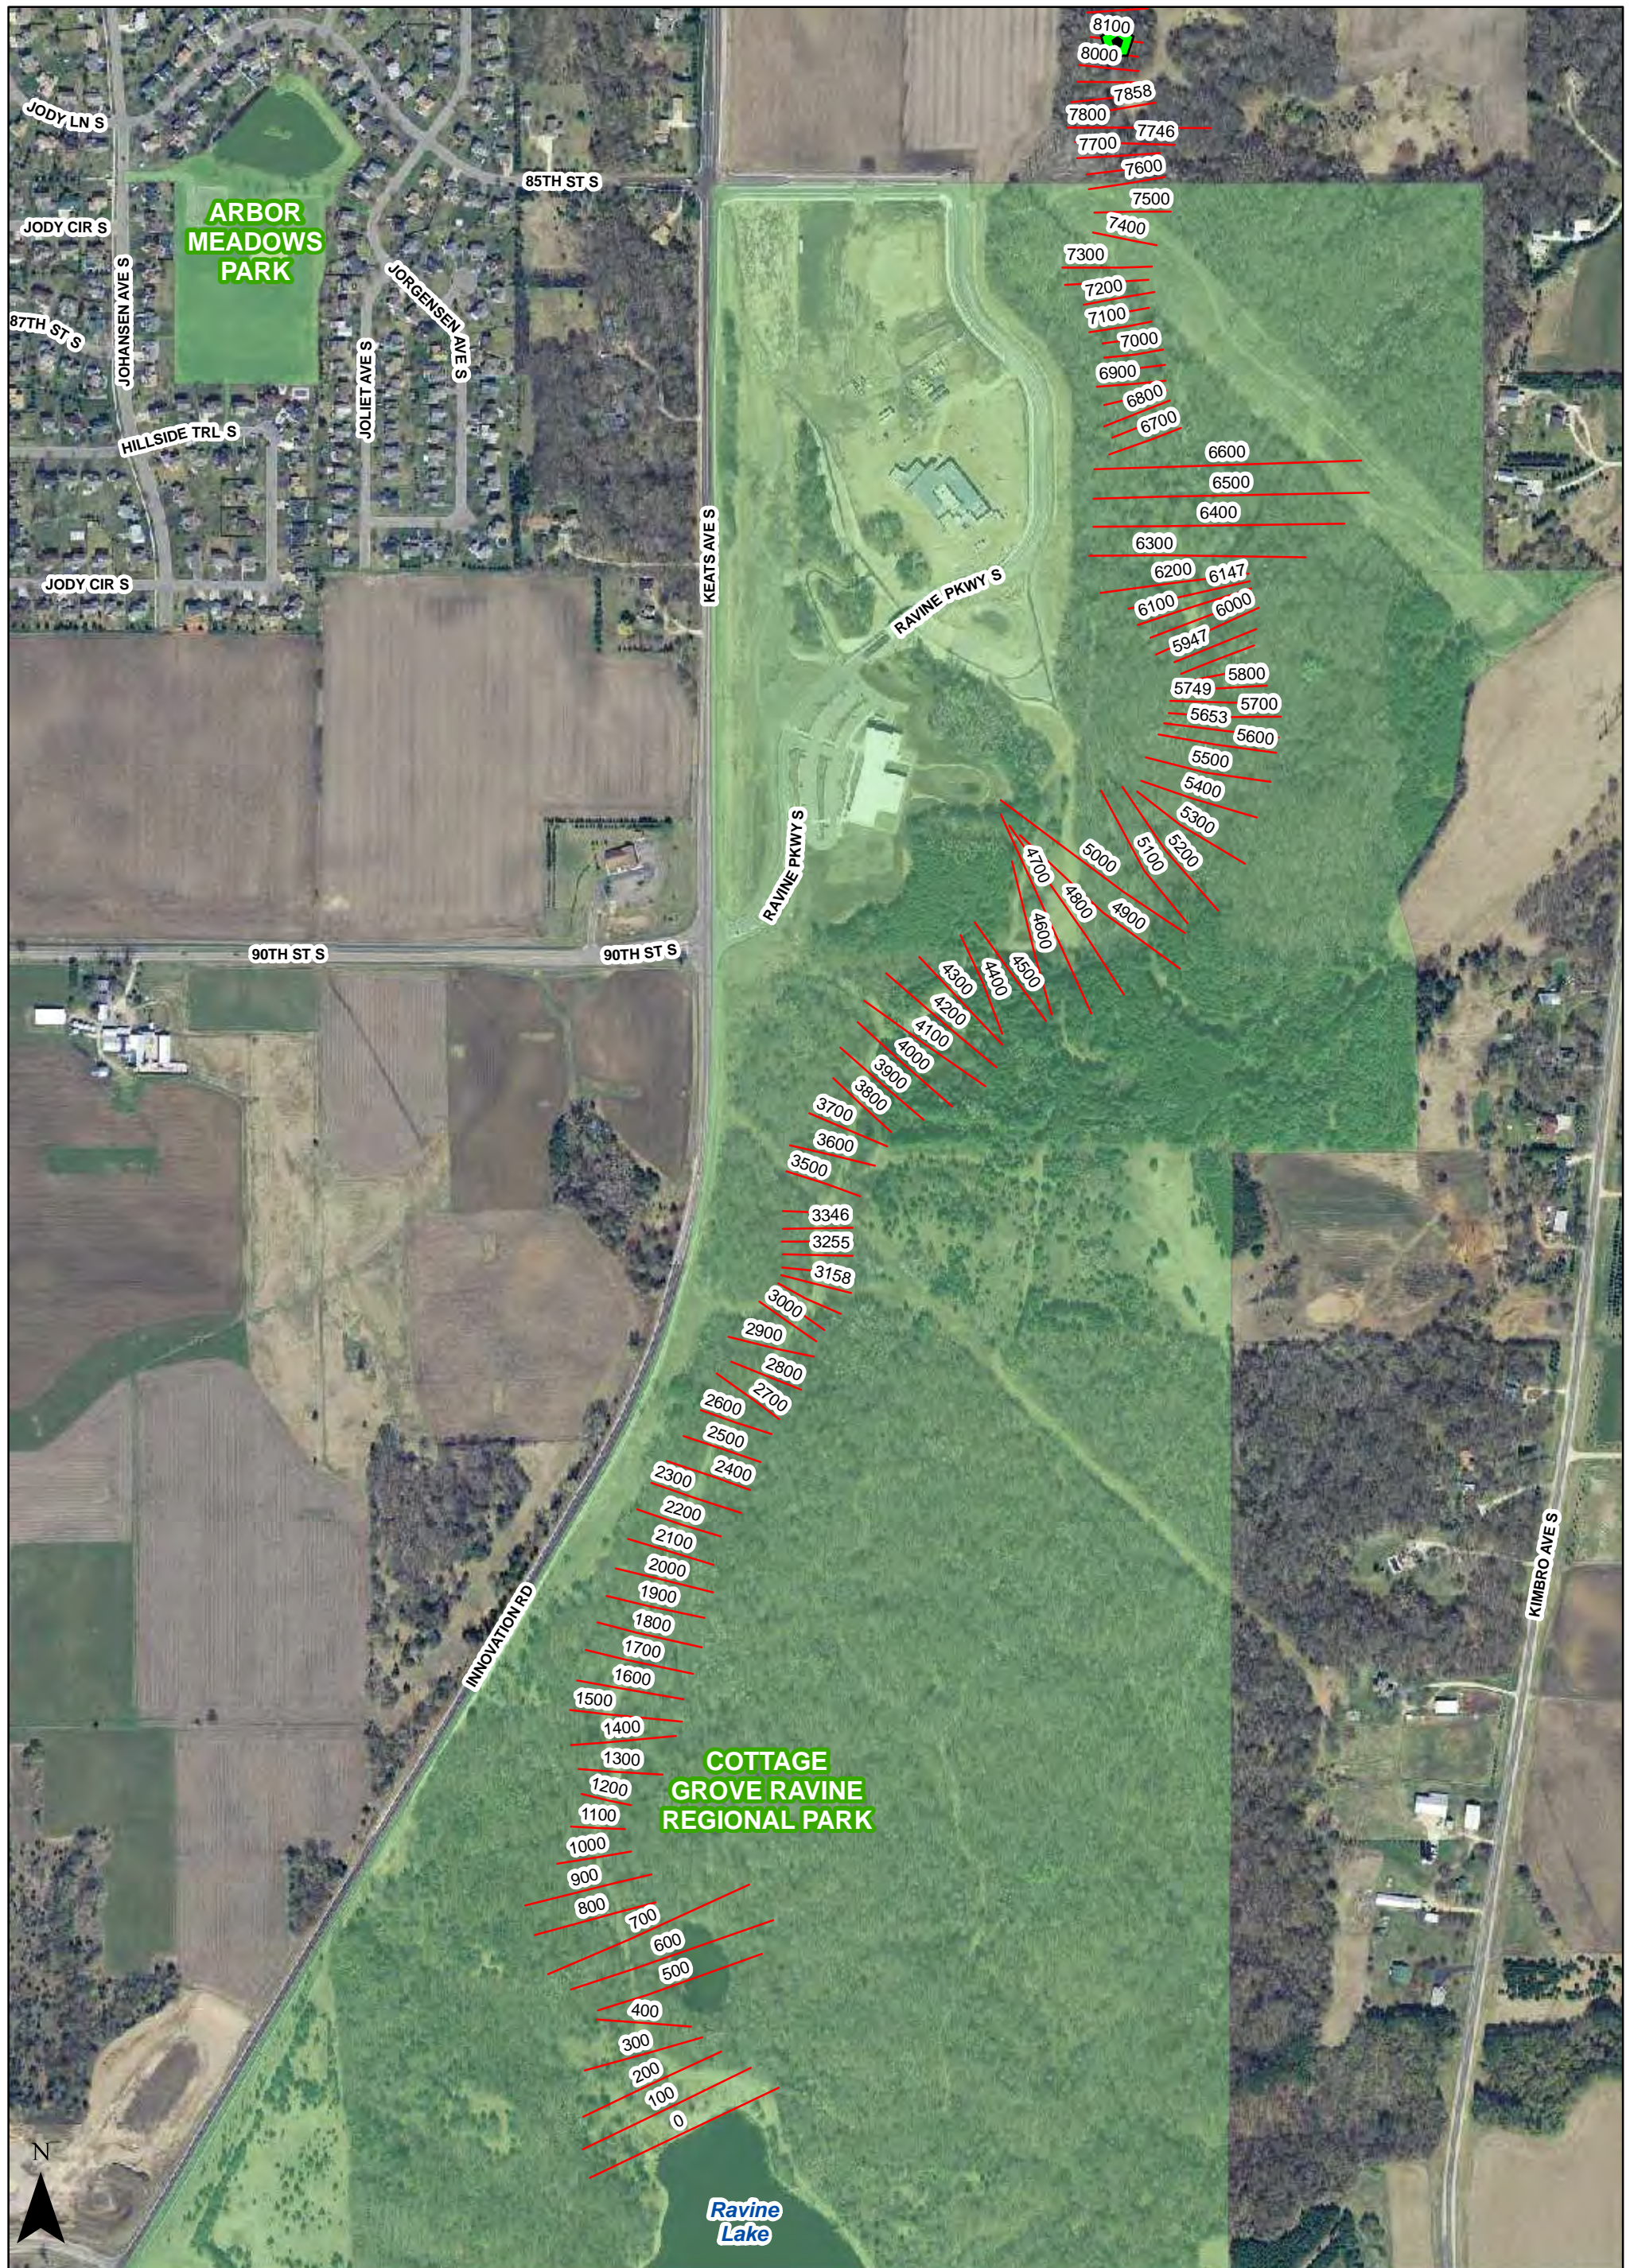
Figure 6: HEC-RAS Model Cross Sections

**Figure 6** shows the location of the cross sections along with the cross section station number. Station numbering along the ravine is in feet beginning at 0 at Ravine Lake. The modeling was carried to station 9300; the proposed outlet from the CDSF Overflow Project is located at approximately station 8100. Because the exact location and final design has not been completed on the outlet, modeling results will be available for this upstream area if needed.

The U.S. Army Corps of Engineer's Hydraulic Engineering Center's River Analysis System (HEC-RAS) model, version 4.1.0, was selected for use in this analysis. HEC-geoRAS, a GIS software tool, was used to help develop the geometry data used to describe the alignment and cross-sectional area of the ravine in the hydraulic model for the reach. The overall model extents and cross section layout are shown in **Figure 6**. These cross section stations are referenced in **Section 4.3** for the various analyses.

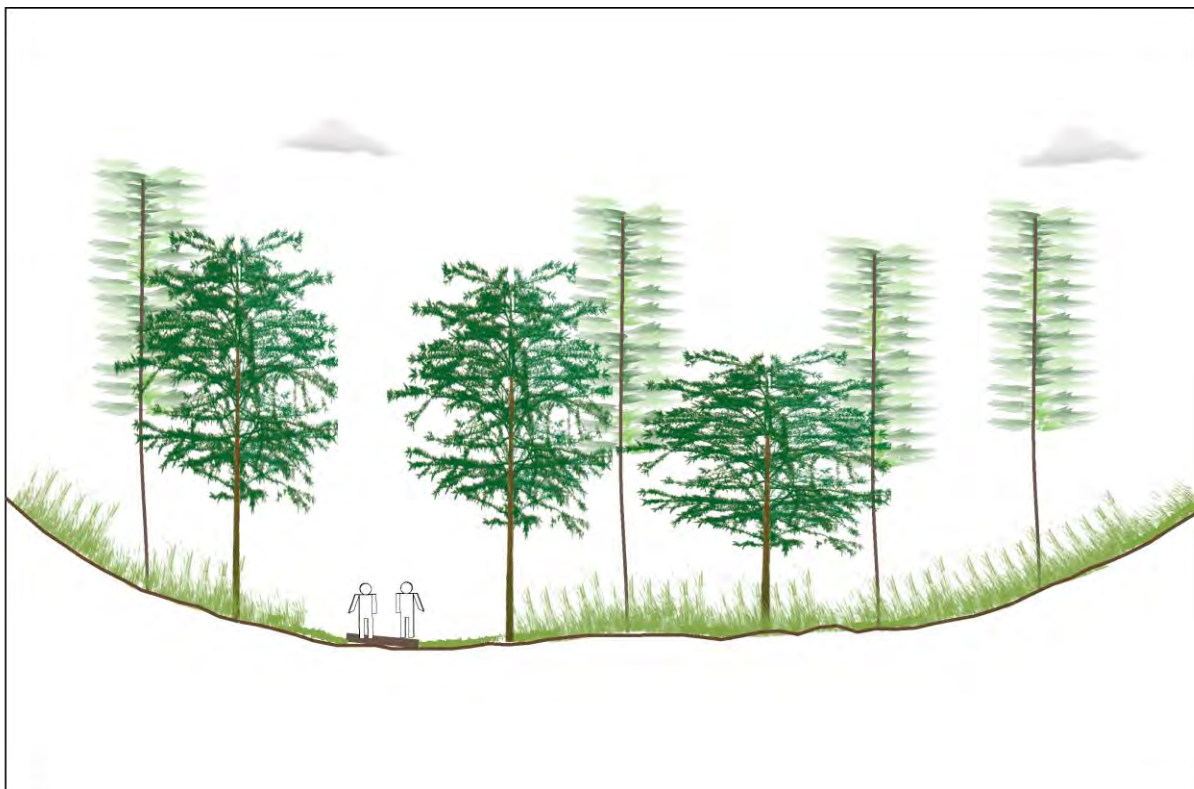
**Figure 12: Rendering Showing the Use of Vegetation Management.**

Managing the vegetation within the ravine is an option to provide stability to the channel in cases where more invasive techniques are not warranted. Restoring the ravine to native habitat would allow longer native grasses to grow and provide the necessary erosion protection. This stabilization alternative would require removal of the buckthorn, other thick underbrush, removal of deadfall, and removal of live trees to open the canopy. The area would then be seeded with native grasses. **Figure 12** shows what this may look like along the trail corridor.

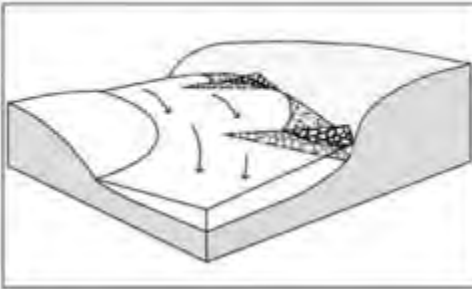
**VANES**

**Figure 8 – Potential Stabilization Techniques downstream of Railroad (Station 5200)**

The upper half of the reach below Ravine Lake is similar to the previous study area through Cottage Grove Ravine Regional Park, and the same stabilization measures apply. However, below the Railroad crossing at approximately station 5200, the channel becomes more incised and prevalent. At approximately station 3200, 3M discharges water into the channel from their facility. This discharge provides a baseflow to the reach. Because of the more prevalent channel and the baseflow, stabilization work through this area will utilize additional stabilization techniques more consistent with a streambank stabilization and stream restoration project. **Figure 8** shows the variety of techniques that may be utilized in this lower portion of the reach<sup>6</sup>. The design will be consistent with methodologies by the MN DNR and Rosgen<sup>7</sup>. Potential stabilization techniques include stabilizing outside bends with rock vanes, woody debris, rootwads, and vegetated riprap. A riffle-pool design will be utilized; the riffles will be constructed from rock using multiple techniques. These techniques are similar to one another with just slight variations of height, length, width and density of rock placement. The stabilization measures ultimately selected will take into account effectiveness at stabilizing the reach, cost effectiveness, and the needs of the 3M.
