- The Trout Brook Ravines - Stormwater Retrofit Analysis

SOUTH WASHINGTON WATERSHED DISTRICT

July 2017

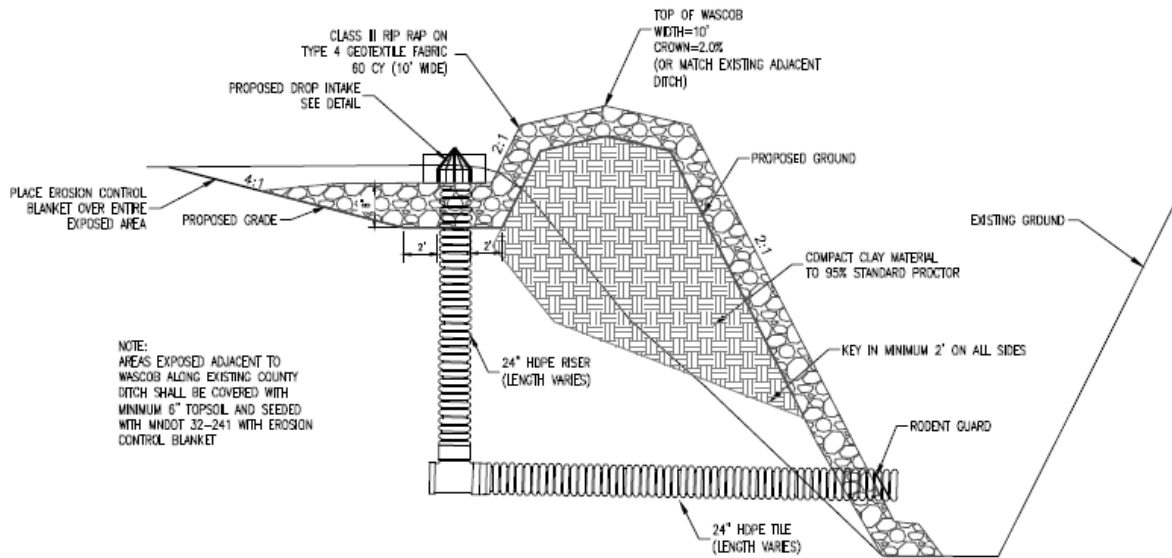
WASCOB SIDE INLET DETAIL

Grade Stabilization Structures – These types of structures are designed to convey runoff across a steep drop in a non-erosive manner. Typical applications include dropping runoff flows from field level down into a ditch with a pipe or an open rock chute. Larger applications such as controlling the advancement of a large ravine or gully up into a field usually involve long lengths of pipe to convey runoff flows down to a stable outlet (MN NRCS). Both practices are used (sometimes in tandem) for many of the sites in this study.

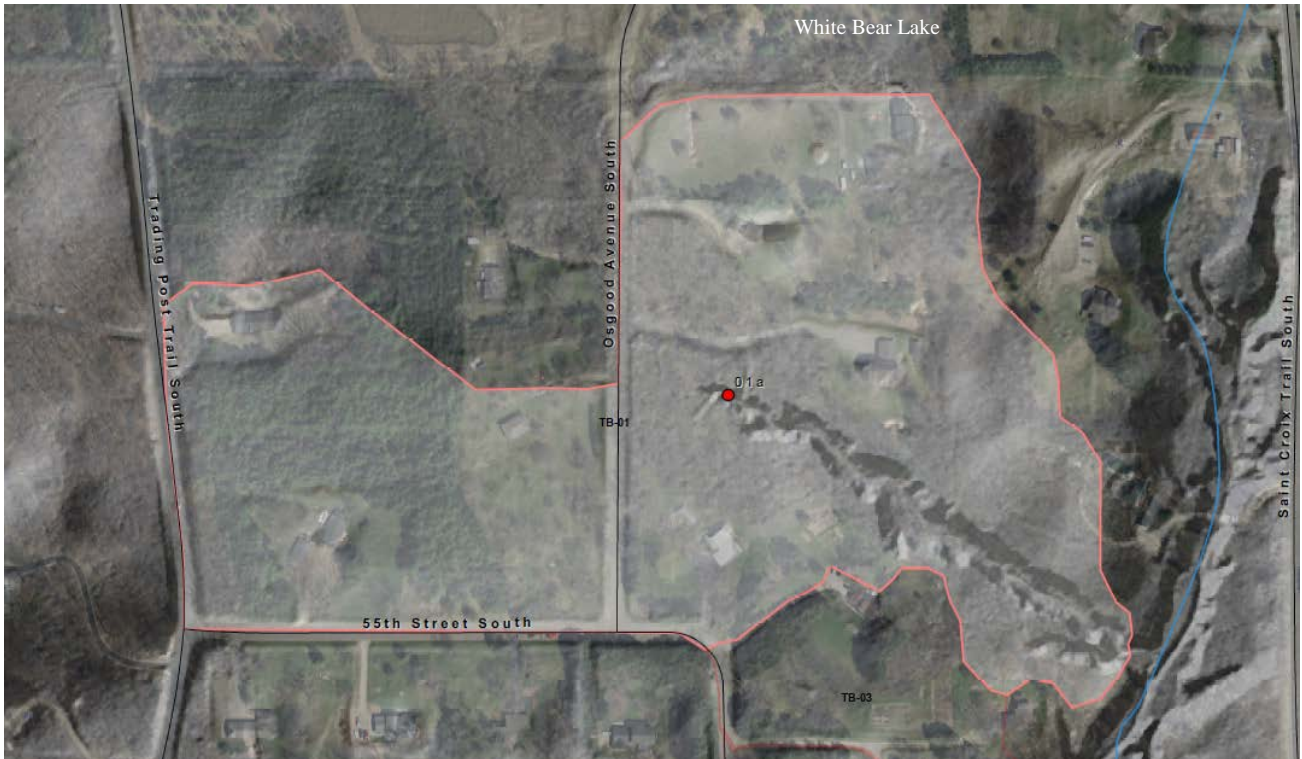
Catchment TB-01 is medium sized ravine and is a mix of low density residential and agriculture. The catchment has been historically agriculture, but has recently built homes. Near the top of the ravine, aerial photos show that this area has always been avoided for farming or tilling. Recently, groundwater issues have increased at the top of the ravine, resulting in many large slumps and slides in the last few years. Increased saturation and groundwater appear to be the driving force behind the losses. The presence of groundwater or saturated soils may explain why this area has not been farmed or tilled in the past.

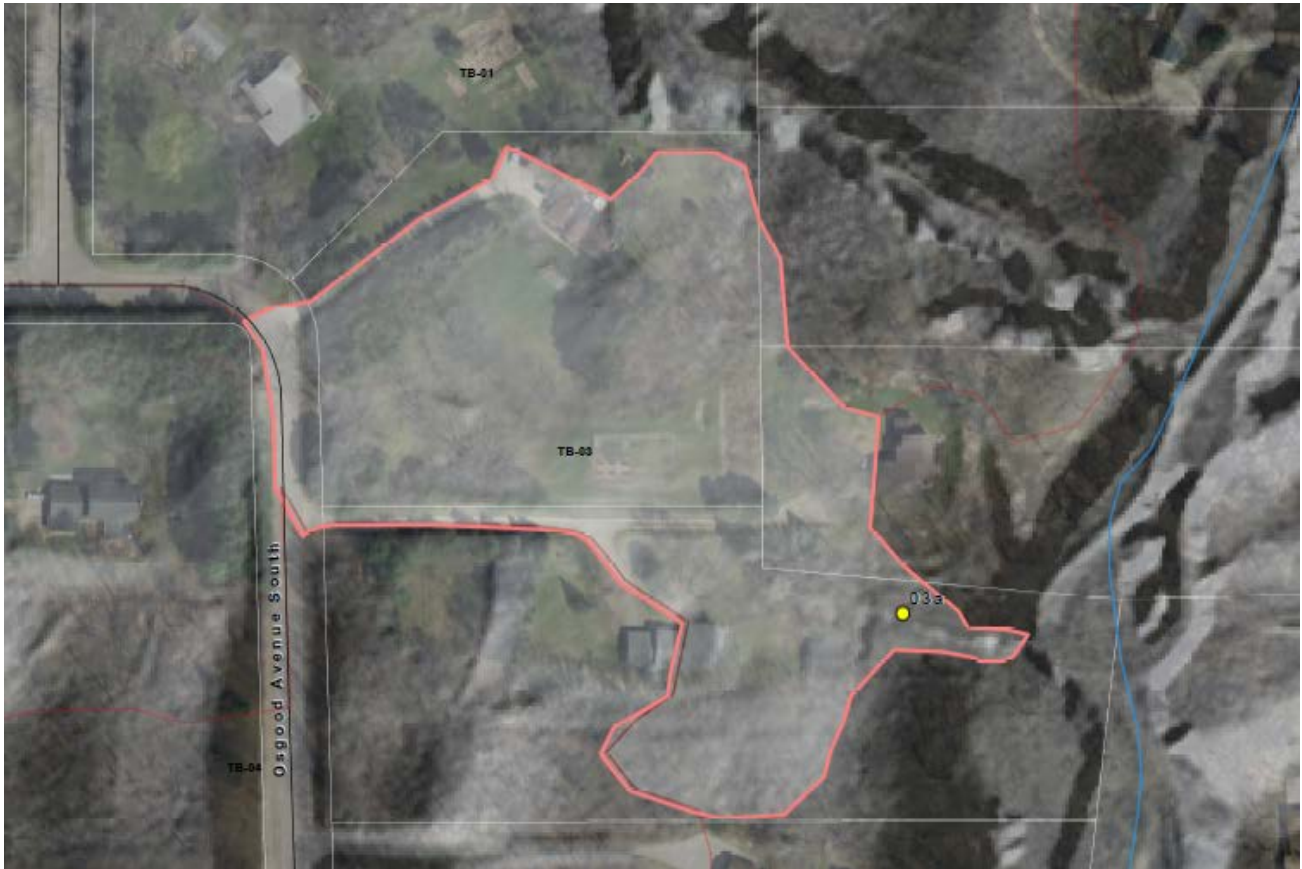
Catchment TB-03 is small catchment with a small steep ravine bordered by two homes. This ravine is showing higher losses than expected, given how small the catchment is. This site is directly adjacent to the TB-01, so it is expected that the losses are from increased groundwater issues, similar to the Litton Ravine.

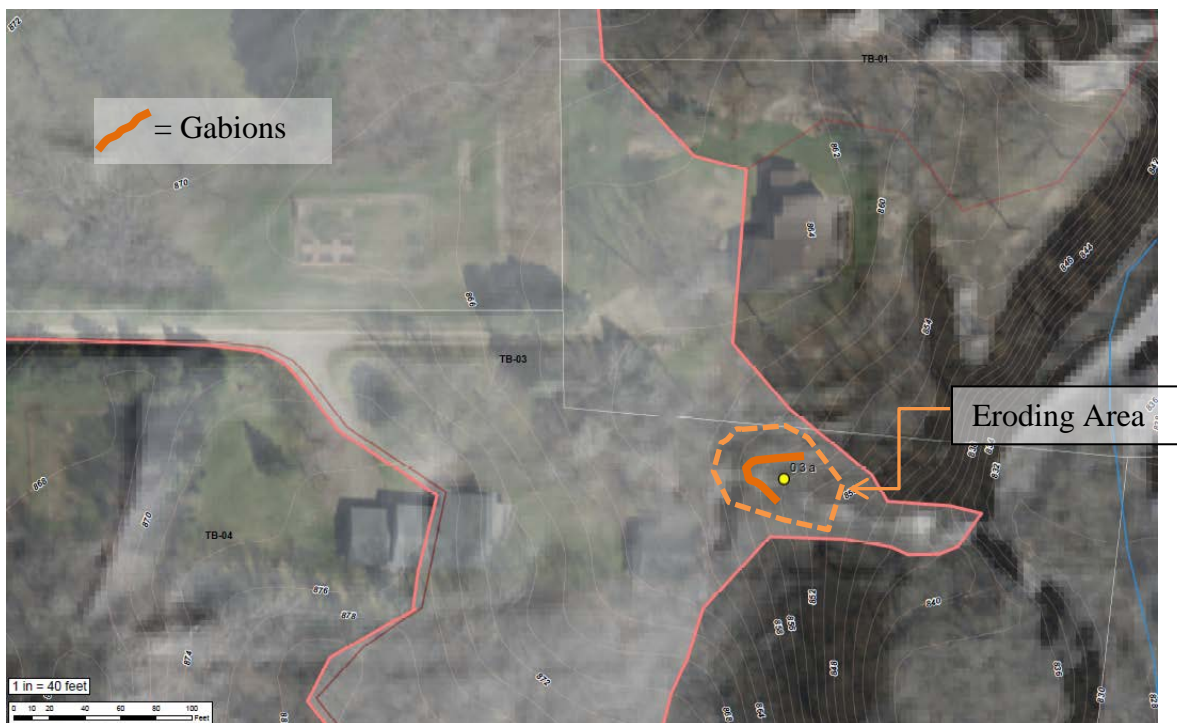
Description – This practice is similar to TB-01 in that it aims to limit slumping caused by saturation at the toes from groundwater exposures.

Gabions will be used as toe stabilization where the seeps are most present. Since Gabions are the main feature, the cost to benefit is fairly low. If a simpler rock armoring and vegetative toe stabilization practice can be used, the install cost would lower and the practice would rank higher.

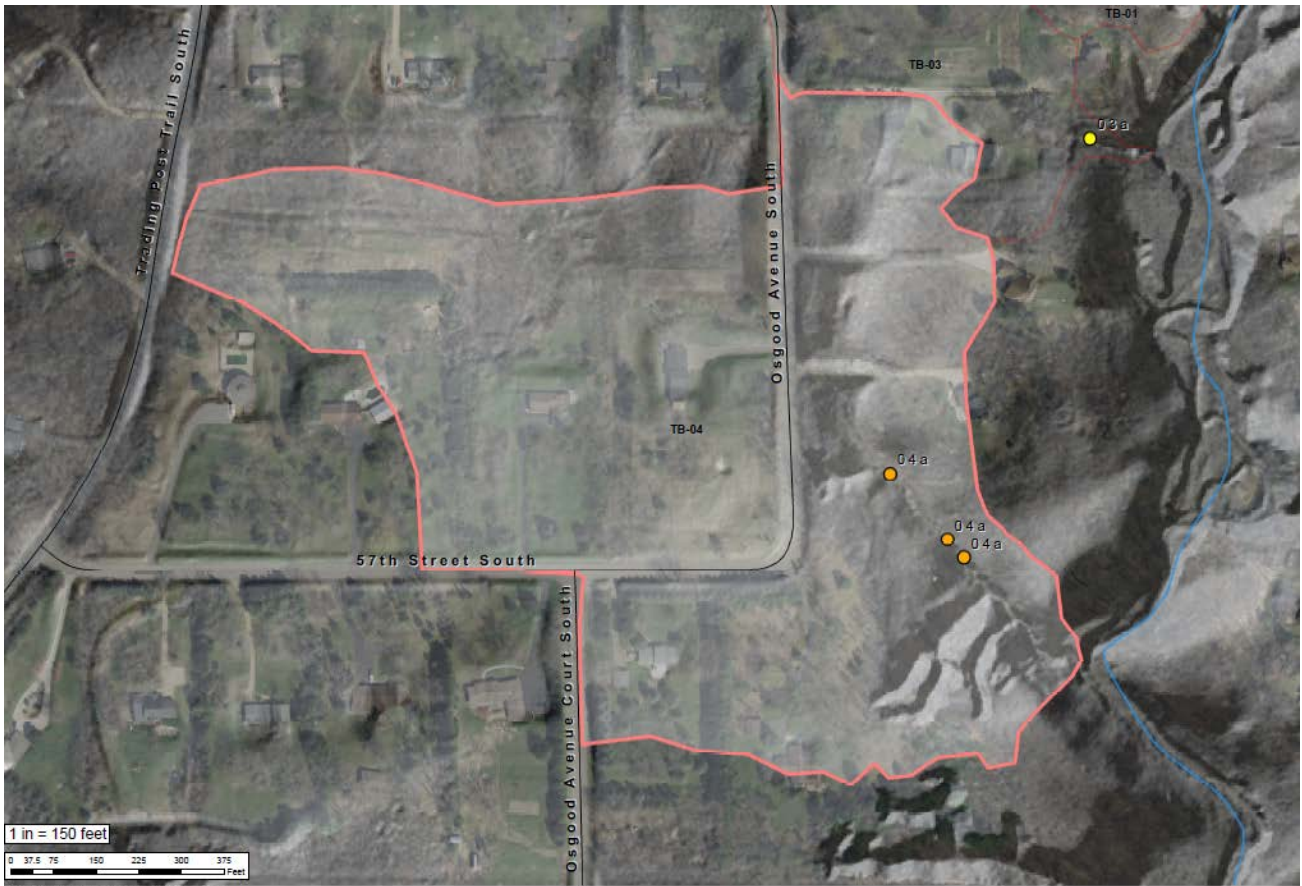
Catchment TB-04 is larger catchment with a long ravine flowing through a city parcel. This has multiple sites where bare soils and head cuts exist. There is also extensive bank failure near Osgood Ave, on the south fork of the ravine. Landowners have tried to fill the cut, but it keeps receding. Groundwater seeps are present in multiple places, and near the same elevation as TB-01 and TB-03.

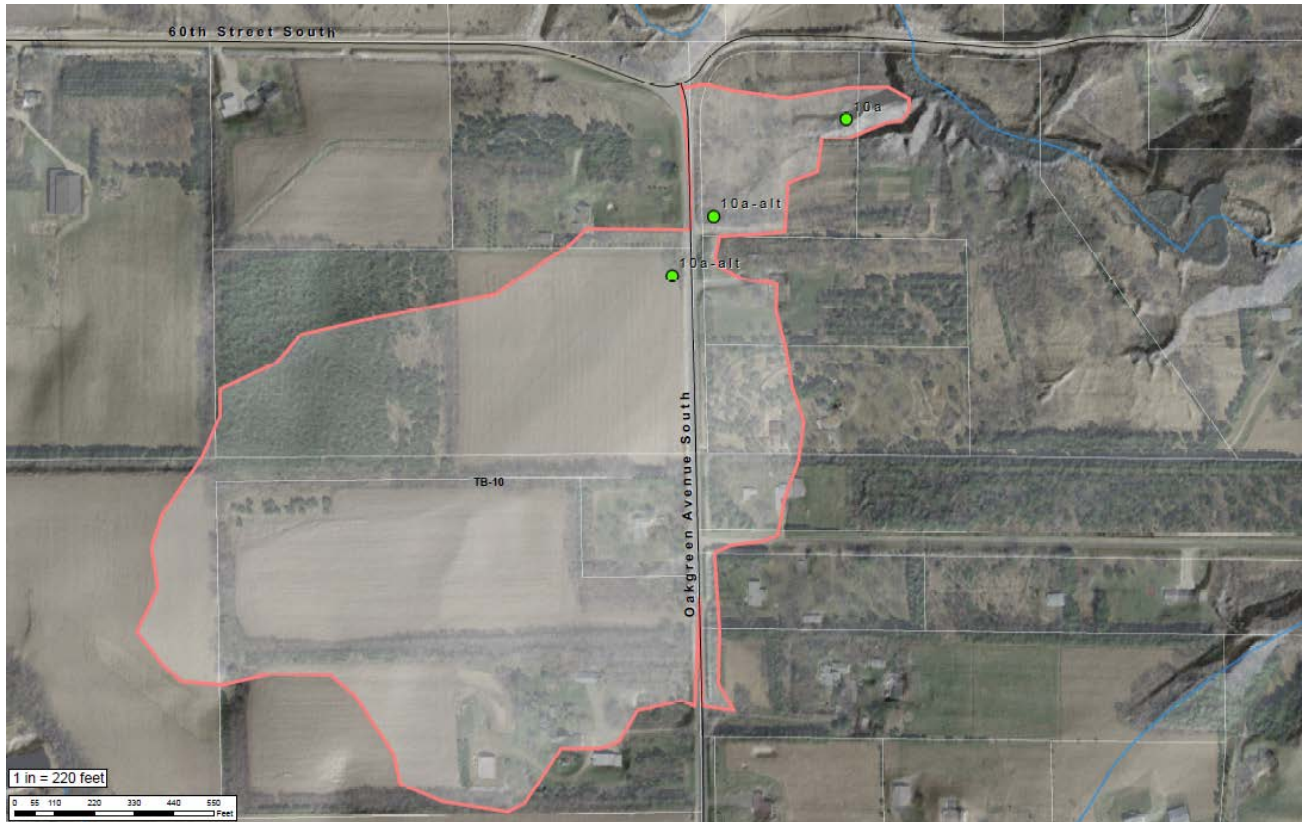
Catchment TB-10 is along Oakgreen Ave S near 60th St. It's a very large catchment, but with shallow grades in the upper catchment before flows cross Oakgreen Ave to the gully area. Historical aeriels seem to show that the majority of erosion occurred prior to 1950; and most new erosion is a result of larger rain events and infrequent groundwater issues.

Repairs could include multiple smaller basins near Oakgreen Ave for rate control, but this report only explores armoring the headcuts in the upper ravine area only.

Description – Repair headcuts with gabions and vegetative armor in upper ravine.

Upper ravine has several smaller headcuts that could be repaired by a 30LF gabion, 1 course high, and revegetating the side slopes. This would be a fairly straight-forward repair and would be similar to the TB-01 and TB-03 practices. Additional volume control was seen as an alternative, but the costs were much less expensive to just armor the headcuts for such a small pollutant load reduction.

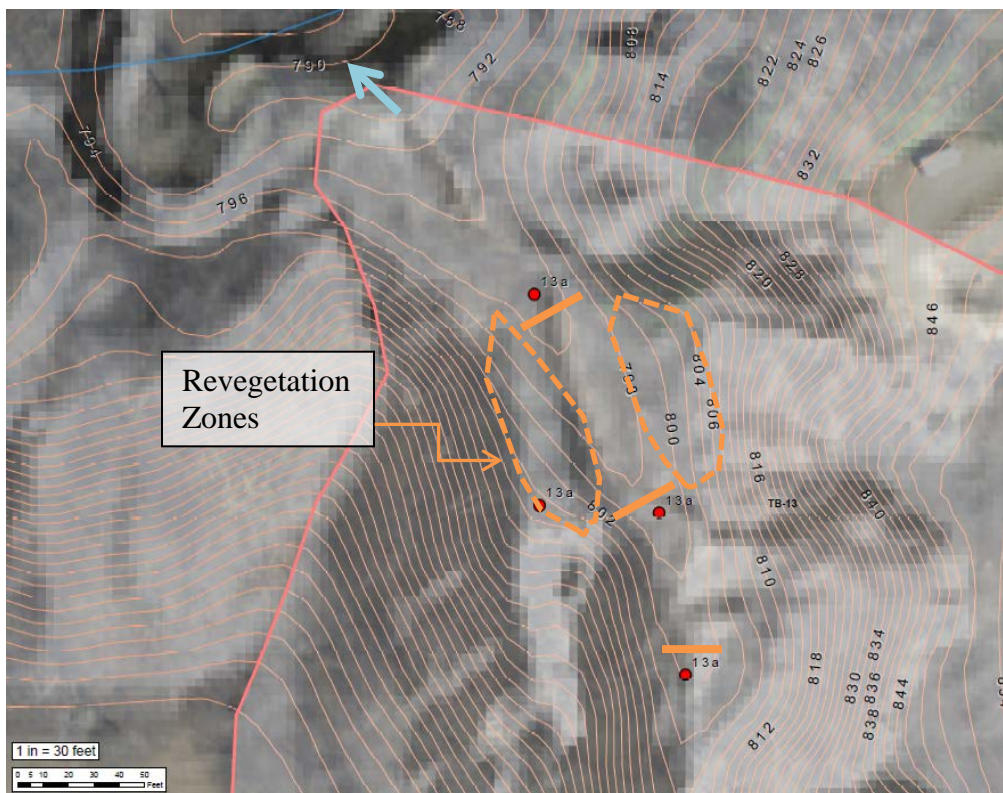
Description – Repair side slopes with gabions and vegetative armor in lower ravine. Practice ranks fairly high due to higher amount of recent erosion and lower repair costs.

Lower 100’ of the ravine has several areas of bank sloughing from groundwater and sandy soil interactions. Slopes and toe could be stabilized by 1 course of gabion wall (60LF) and vegetative restoration. Clearing of 0.33 to 0.5 acres of trees and buckthorn would create more light availability for new vegetation to take hold. Three riprap checks could be installed in the channel to prevent further headcutting, but further analysis should be performed on the channel bed composition before installing any in-channel practices.

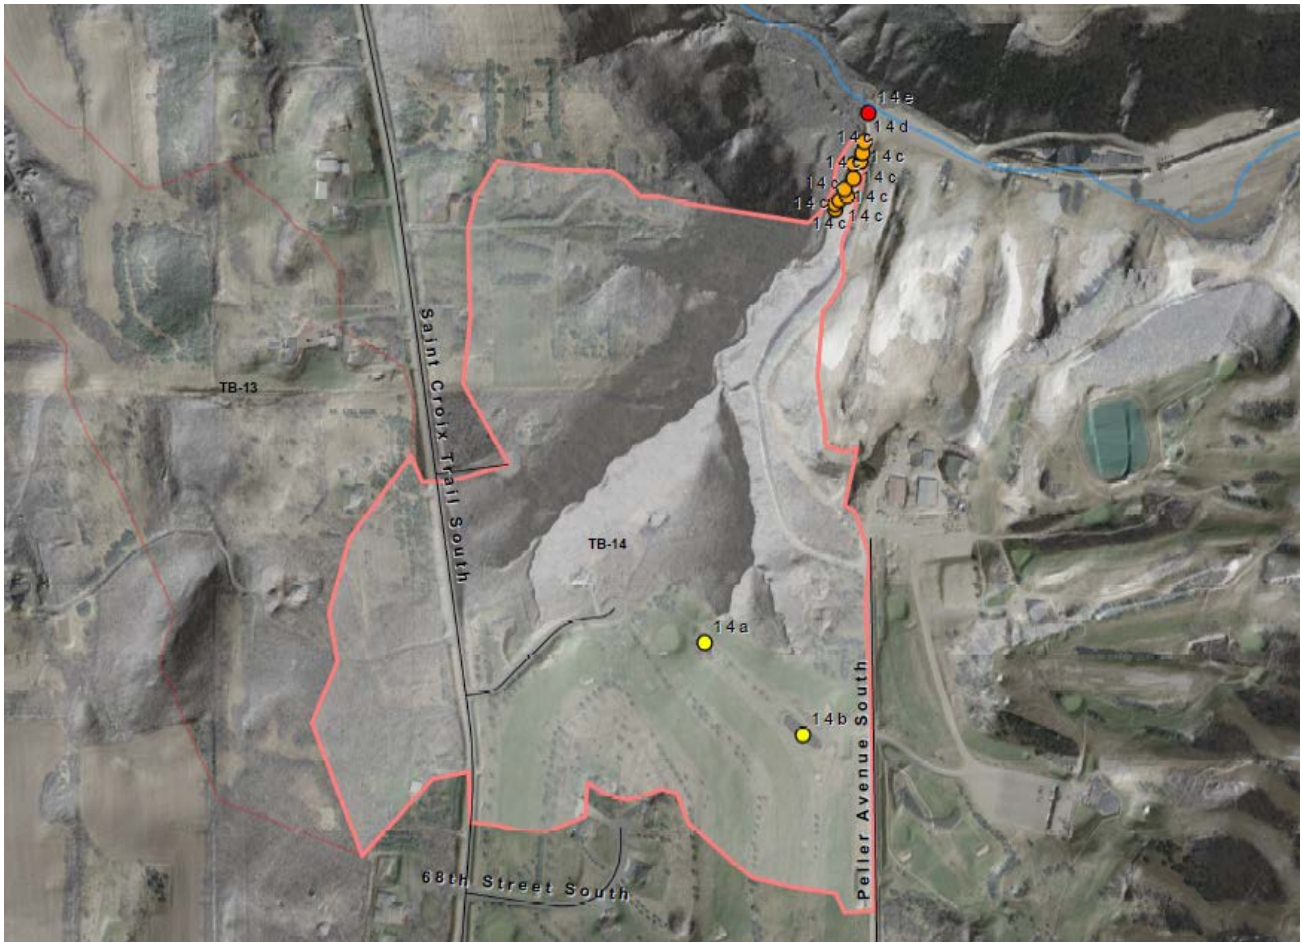
Catchment TB-14 is very large and runs from the Afton Alps Golf Course to the Afton Alps Parking Lot. Historical aerials show that the majority of major erosion occurred prior to 1950, with a second and third wave of major erosion resulting from the initial golf course development (circa 1960) as well as the recent storm sewer additions that discharge from the Afton Alps entrance road (2015).

The ravine channel bottom appears to be relatively stable since much of the ravine channel is large cobble with some bedrock exposures. Most erosion observed is from bank losses. Correction in this ravine should be similar to in-stream management techniques since the flows behave more like a river than an ephemeral gully. Many of the bank losses can be corrected by minor thalweg adjustments to prevent undercutting and mass wasting. Other erosion can be prevented from adjustments to the new pipe outfalls in the lower third of the ravine (new pipes that discharge Afton Alps entrance road).

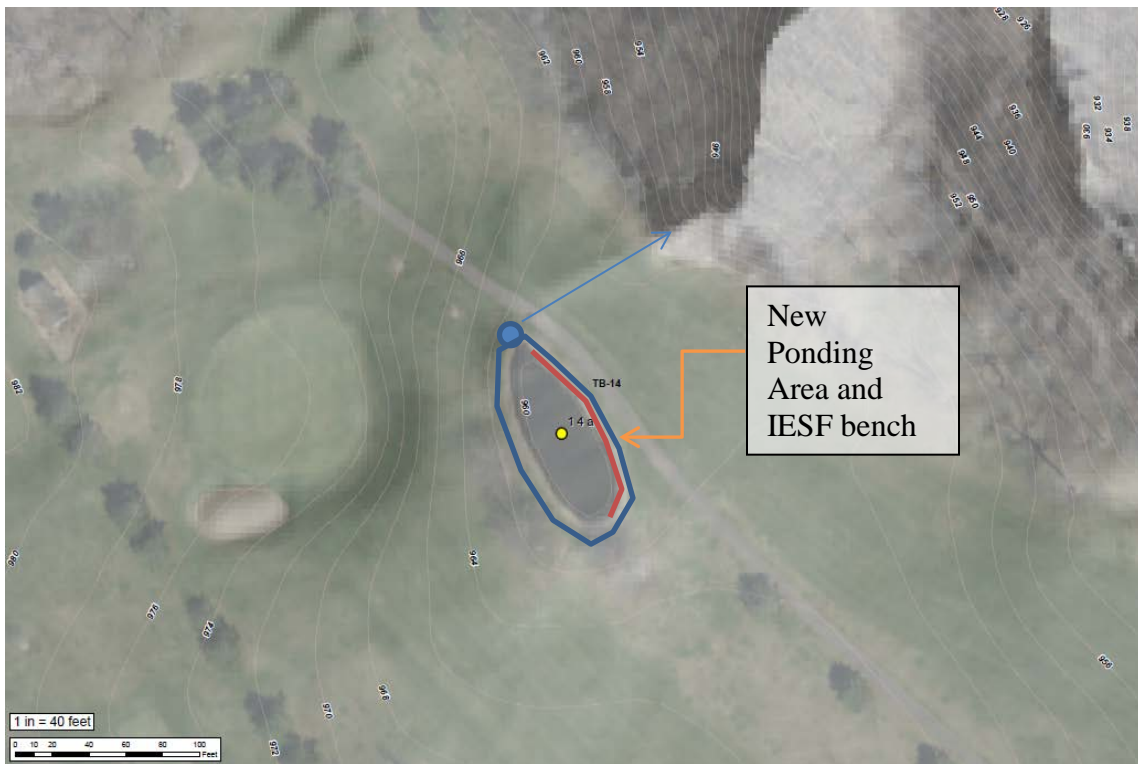
Install new outlet structure to allow raising the pond outlet 6-9” and the emergency overflow berm by 1.5’ (EOF storage area expanded by 1600 sf). Up to 120 lf (480sf/960cf) of iron enhanced sand media can be installed along north edge of basin. New draintile for the IESF bench will have to be trenched to the ravine. Pollution reduction would be primarily for soluble phosphorus, as the existing pond volume is already sized for adequate TSS reductions. The ranking is low relative to other practices in this study, but the cost per pound of TP is in line with a retrofit of this type. The overall cost/benefit still makes it a higher ranking project in most other urban SWAs.

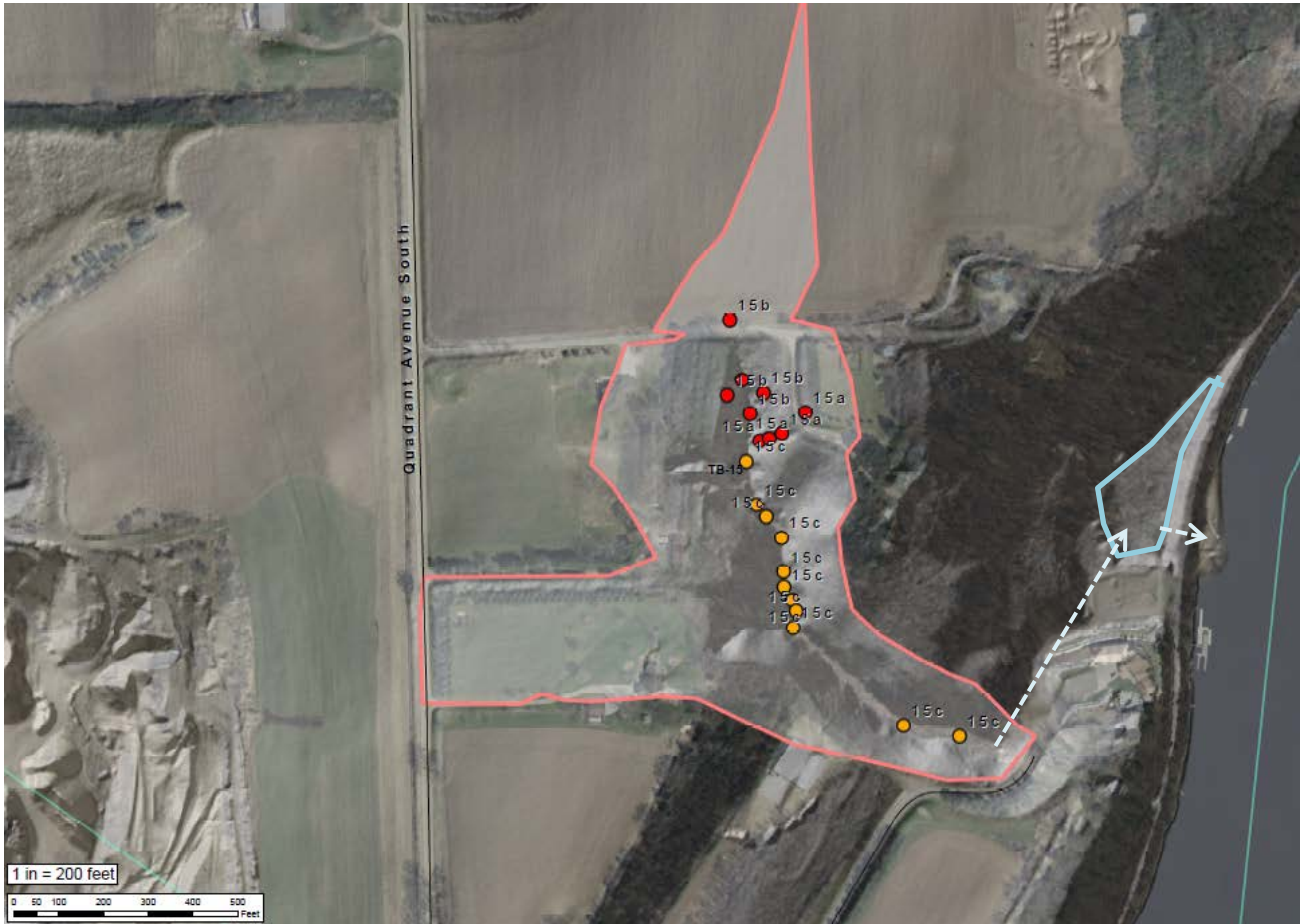
Catchment TB-15 has a relatively small drainage area compared to the amount of erosion observed. This is a very active gully, with very large amounts of the upper ravine bank areas being eroded annually. Most of the soil loss looks fairly recent on the side slopes. Historical aerials show that much of the major erosion occurred prior to 1950 and the catchment size may have been reduced due to diversions away from this gully (from the west). To explain the losses occurring today, we can only conclude that once the process of down-cutting and toe failure hit a critical depth, a negative feedback loop of undercutting steep, sandy, bare slopes begins which becomes hard to stop.

Divert flow from the northern catchment. There is a 12” pipe that drains a small portion of farm field that is actively cropped. This flow can easily be diverted in a new ditch (300lf) that flows to the west, to join up with a safer flow network. The forest above the ravines is red pine with barely any understory. Thinning of this pine stand and revegetation should occur to promote upstream infiltration. In this section of channel, there are a lot of fallen trees that can be used to stabilize the toe. Use multiple cross vanes or check dams to keep channel flow diverted from bank toes. Add 400 sf infiltration basin to east ravine reach and armor headcuts with combination of checkdams and cross vanes. Hydroseed 15,000sf of bare slopes. This cost estimate appears low, but it assumes that 15c will be constructed in tandem and the costs of accessing the site are minimized. It is also assumed that most of the toe stabilization material will be from trees already in the ravine (brush packing and shrub planting the toes). Even if the cost of this installation were doubled, it would still rank as a top 5 practice.
